Test Report Number:	4E14170	Product Assessment and Reliability Centre Ltd Unit 4 Alverdiscott Road Industrial Estate	
4	Issue:	1	Bideford, Devon, EX39 4LQ Telephone: +44 (0) 1237 421255 info@parctest.co.uk www.parctest.co.uk	
	Date of Issue:	03/11/2025	Commercial in Confidence

2 off HS-420d Sensor PARC ID: EUT 1
PARC ID: EUT 2

SECTION				
Tests performed in order unless otherwise specified:		Using the parameters and methodology of:		
IP6X Dust Ingress	UKAS	BS EN 60529:1992+A2:2013		
IPX8 Water Ingress	UKAS	BS EN 60529:1992+A2:2013

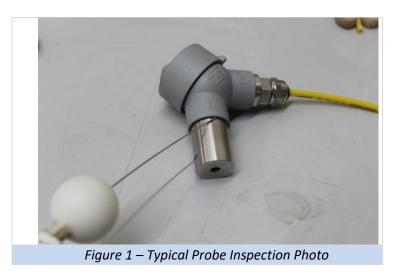
No apertures or openings identified that allow penetration of a 1 mm probe.
